# TECHNICAL BULLETIN

## Silicone water level grommet deterioration

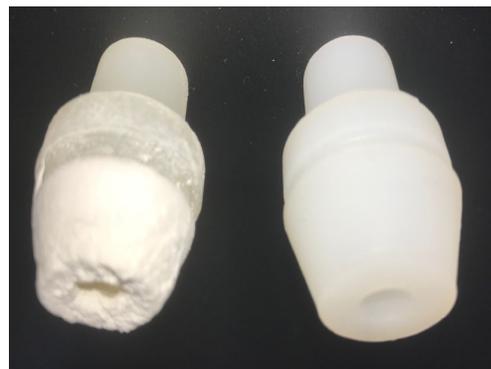
The grommet is press fit into the tank and can be removed by squeezing and pulling upwards. Defective grommets have a white chalky looking coating on the bottom half of the grommet that is inside the tank. This can be seen in the top picture on the left grommet.

**Remedy:** replace grommet (part number 1024.00053.00) and test machine.

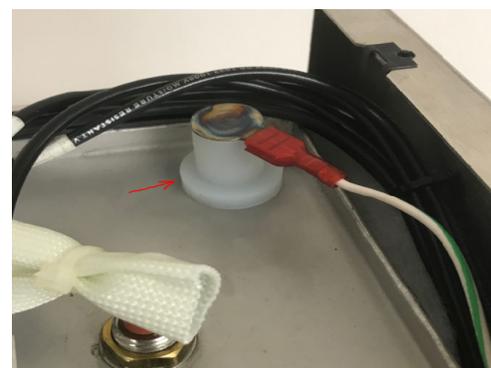
**Description of Problem:** Due to deterioration, the grommet may become conductive and cause false readings due to the water level probe grounding to the tank. **Note: there is no voltage on this connection (middle picture), but there is voltage on the element next to it.** Once deteriorated, the machine will not fill completely, causing the water level in the tank to be lower than it should, thus causing short potting.

**Problem identification and testing:** **Caution, live voltage present!** To see if the grommet is at fault, remove the probe by pulling straight up (there are no fasteners). If the machine is in ready state and does not activate the fill valve, check the valve for a fault. If machine is in ready state and begins to fill, touch the end of the probe to the metal on the top of the tank. If the filling stops, check the condition of the grommet and replace if necessary.
